A TORNADO AT WATERTOWN, SOUTH DAKOTA, JUNE 23, 1914.

J. GLADDEN HUTTON.

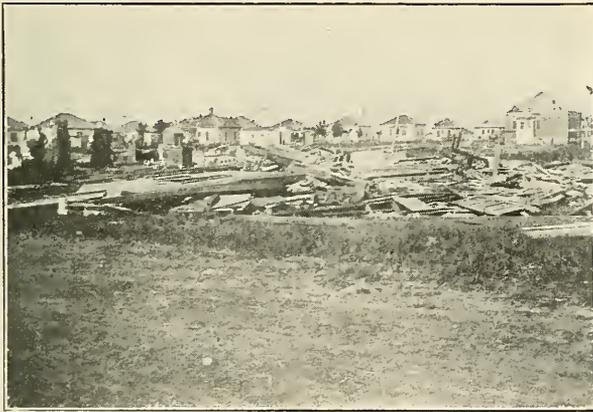
FIG. 3. View showing wreckage of house in southwest part of Watertown, S. D. General character of houses indicated.

the middle of the path total destruction occurred, though not at all points. Greater destruction seems to have occurred on the right side of the storm path than on the left, and at some points the axis lies to the left of the middle of the path. The destruction seems to have been greatest where the storm entered the city and where it left it. The light construction of many of the houses in the part of the city traversed seems partly responsible for the damage. (See Fig. 3.)

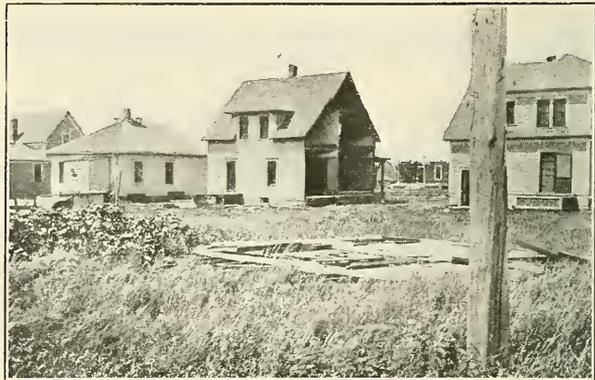
FIG. 4. House with end blown outward.

The entire end of the house shown in Figure 4 was blown outward. The end of the house may be seen lying in the foreground.

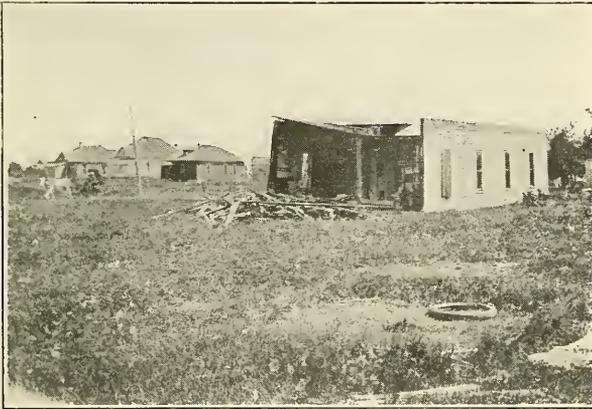
Figure 5 shows a similar condition, though the house was greatly damaged otherwise.

FIG. 5. House in east Watertown, S. D., showing explosive effect of air during passage of tornado.

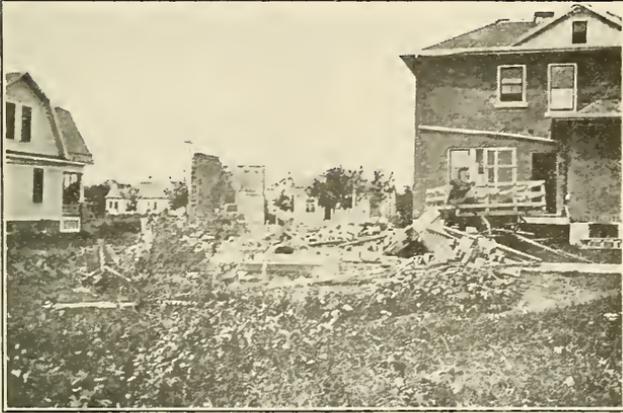
Hollow cylindrical porch posts were split in at least one instance. Walls or foundations made of hollow cement blocks or hollow tile failed in many instances. (See Figures 9 and 10.)

FIG. 9. Collapse of hollow tile structure. Watertown, S. D., June 23, 1914.

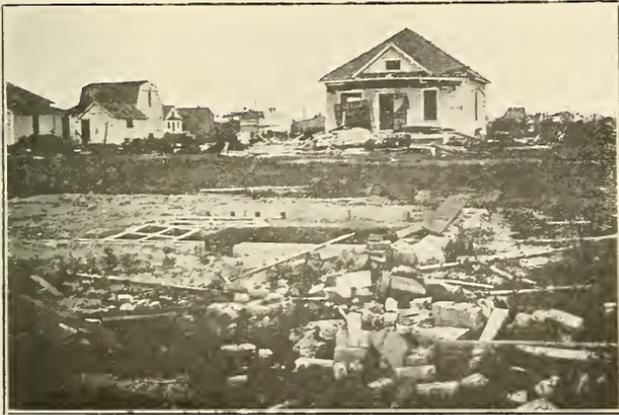
Fig. 10. The house from the foundation in the foreground was carried bodily across the street and then dropped to the earth and broken to bits. Wreckage may be seen in front of cottage on the right.

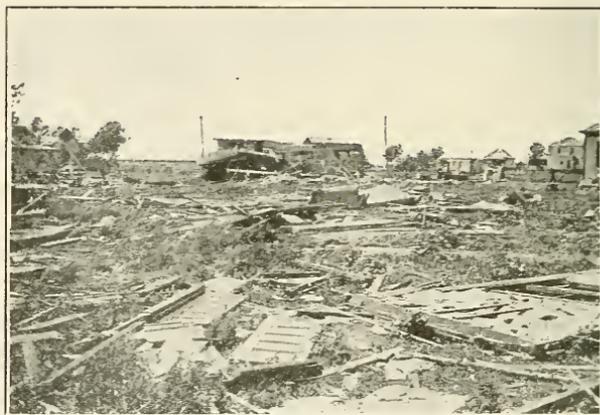
FIG. 11. General view of wreckage where destruction was greatest.
Watertown, S. D., June 23, 1914.

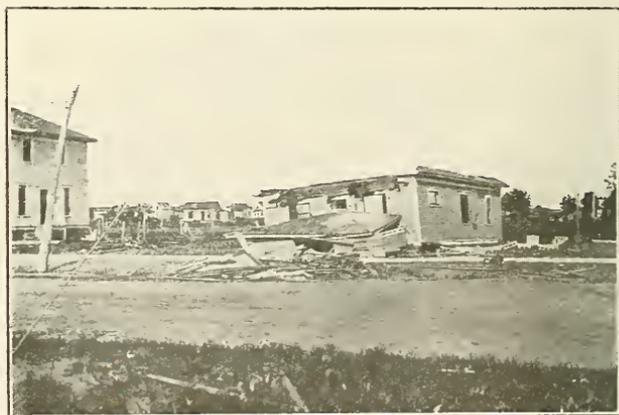
FIG. 12. House moved from foundation. Watertown, S. D., June 23, 1914.

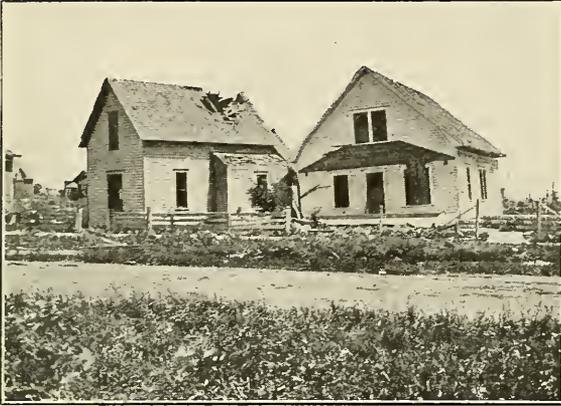
FIG. 13. House moved from foundation. Watertown, S. D., June 23, 1914.

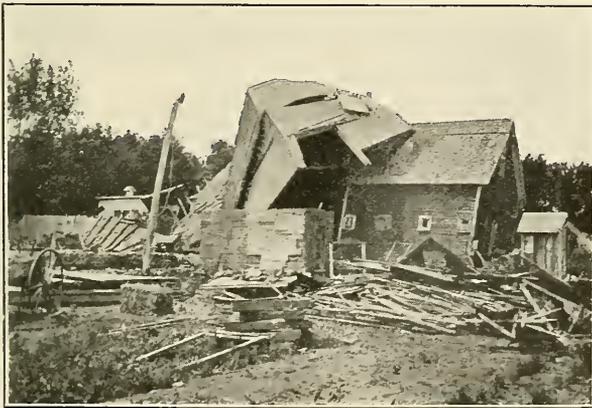
FIG. 14. Effects of tornado, Watertown, S. D., June 23, 1914.

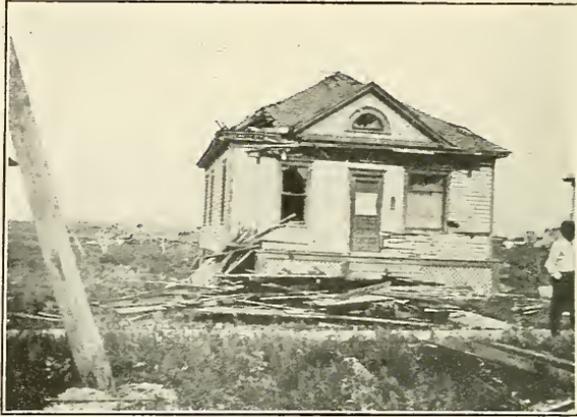
FIG. 15. The tornado passed to the left of this house moving toward the reader. The porch was torn away and deposited in the rear of the house. Watertown, S. D., June 23, 1914.

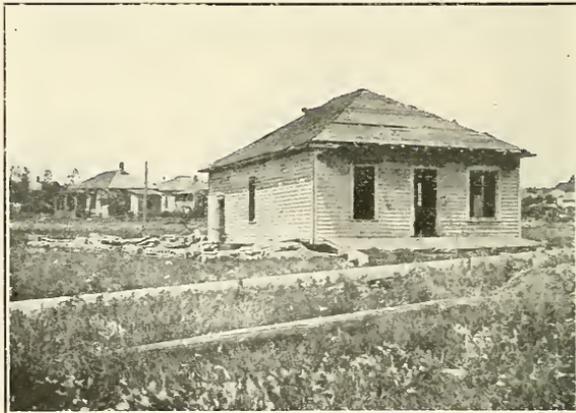
FIG. 16. House moved from its foundation. Shingles stripped from roof. Tornado passed to the right of it. Watertown, S. D., June 23, 1914.
