A TORNADO AT WATERTOWN, SOUTH DAKOTA, JUNE 23, 1914.

J. GLADDEN HUTTON.

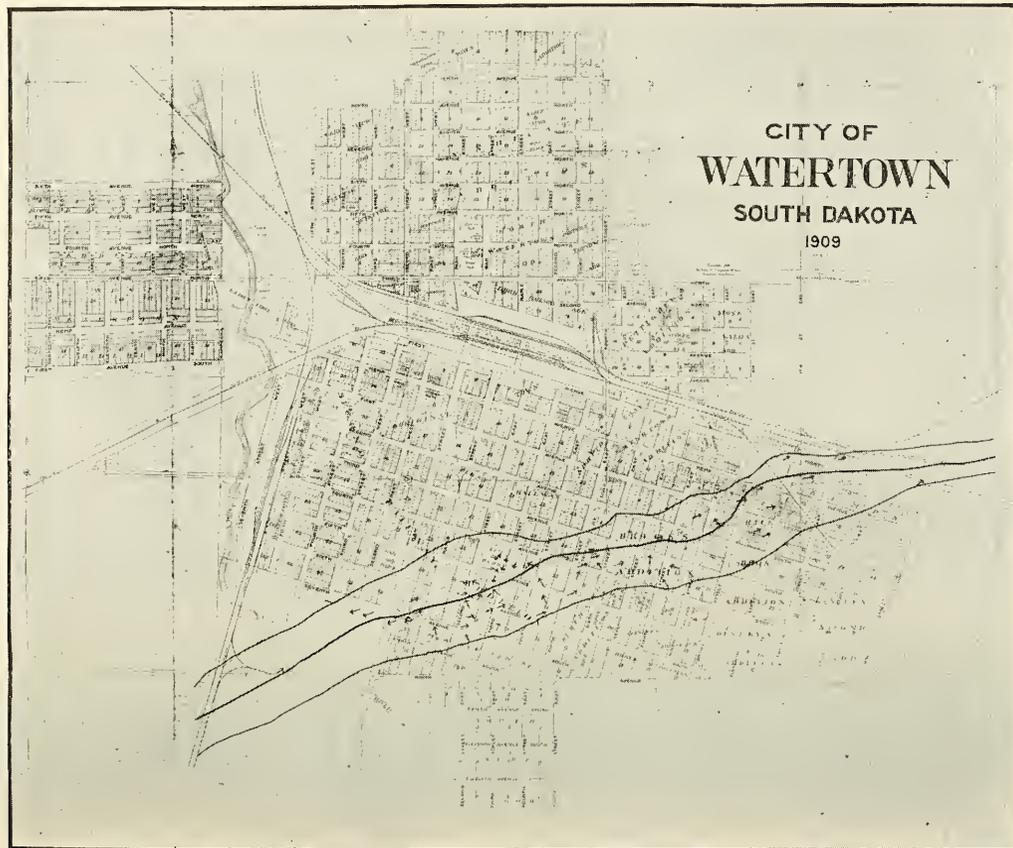
FIG. 1. Map of Watertown; S. D., showing path of tornado of June 23, 1914. See text for explanation.

The writer carefully examined the path of the storm from the point where it entered the city to the point where it left the city and passed out into the open prairie. The two outside lines shown in Figure 1 indicate the boundaries of the zone of damage, while the middle line is the locus of points where the greatest destruction occurred. The small arrows indicate the direction in which objects moved as assumed from their position before and after the storm. The writer is aware of the fact that in cases where objects were moved for some distance the arrows may not indicate the direction of movement, but where houses were only moved slightly

from their foundations, and in similar cases, the arrows indicate the actual direction of movement. On the right of the axis of the path objects seem to have moved forward and to the left, while on the left side of the path they moved generally backward and to the right with reference to the advance of the tornado, although there are exceptions to this general statement.

Houses on the edges of the path had their chimneys damaged. In fact the outside lines might be designated the chimney lines. Inside the chimney lines, shingles were removed in patches and usually on the side of the house nearest the axis of the storm. Farther in more shingles were removed, porches were blown away, roofs entirely removed and in

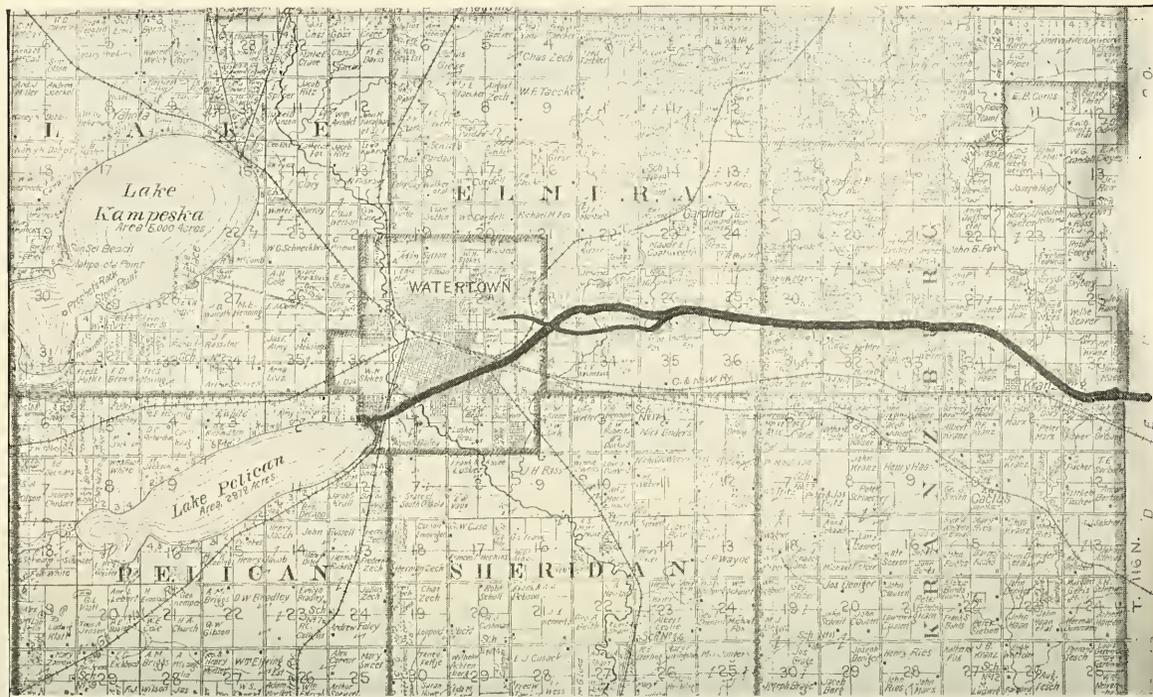
FIG. 2. Map of eastern Codrington County, S. D., showing path of tornado. The heavy dark line beginning at the northeast end of Lake Pelican indicates the path of the principal tornado. A lighter line crossing the heavy line at the eastern boundary of the city represents the path of the second funnel referred to in the text. Mapped for the writer by Mr. H. Mathiesen.

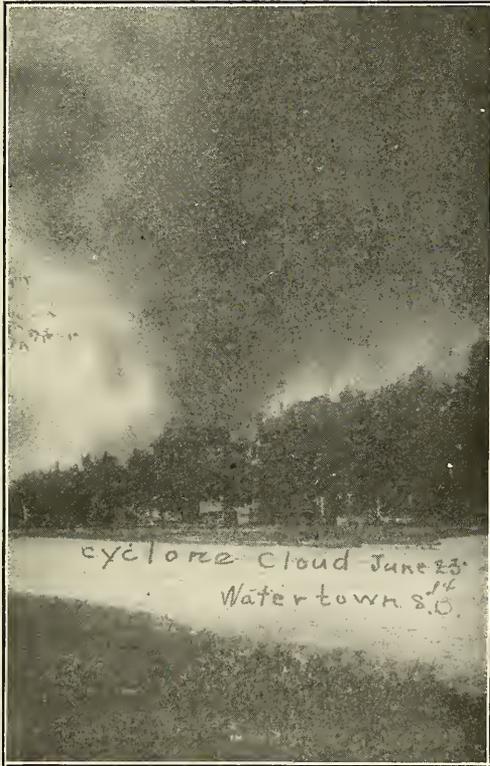
Figure 7 is from a photograph said to have been taken by a traveling salesman at the corner of Maple street and Second avenue south. This point is about four blocks north of the axis of the storm path. The other photographs were made by the writer.

FIG. 7. View of tornado cloud, Watertown, S. D., June 23, 1914. Name of photographer unknown
