Economic Groundwater Problems Encountered in the Development of a Housing Area Near West Lafayette, Indiana

TERRY R. WEST and DAVID J. BARR, Purdue University

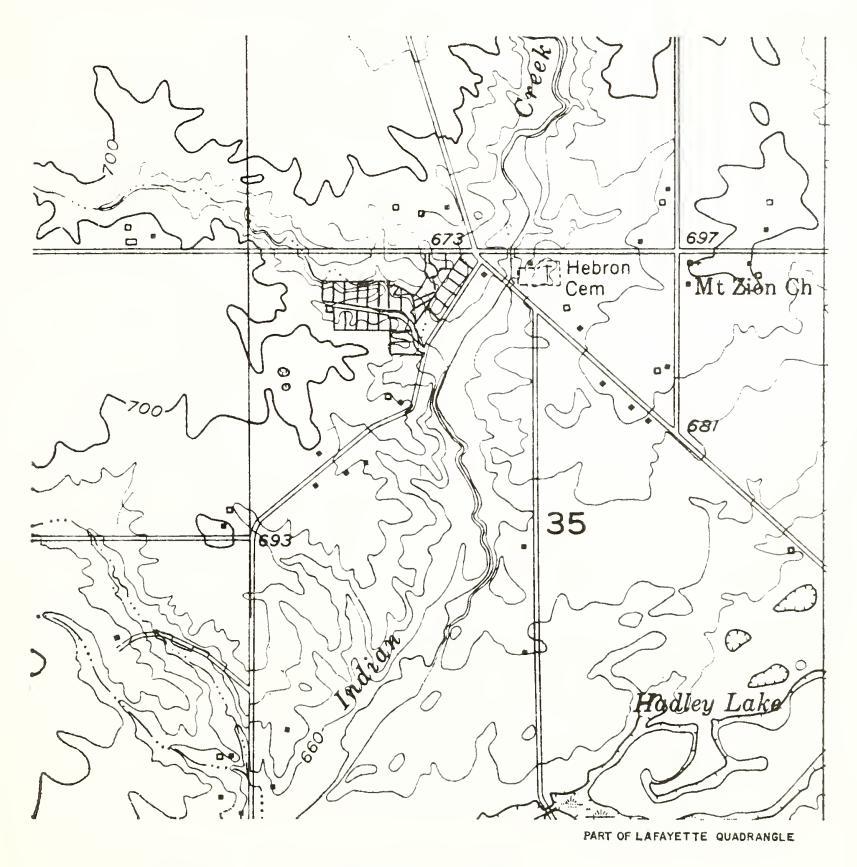
FIG.I. TOPOGRAPHIC MAP OF THE HOMEWOOD AREA

At present the housing development consists of twenty homes of contrasting design which are located on about fourteen acres. The topographic setting of the area is shown in Figure 1.

In section 35 of Tippecanoe County the surface is essentially flat to gently rolling. The maximum elevation in the area is 700+ feet whereas the maximum relief, created by dissection of the glacial drift, is on the order of 40 feet. Homewood Addition is situated on the sloping divide between the upland till plain and the lower outwash which forms a low swampy area elongated in a NE-SW direction. Hadley Lake and Blackbird Lake lie in this trough which may have originated as a sluiceway for glacial melt water. Schneider and others (2) have suggested that this elongated lowland is composed primarily of sand and gravel and that it may be an esker trough. Indian Creek enters this trough south of the Homewood area where it occupies the western margin of the depression and serves as the major drainage system for the till plain. In Figure 1, it can be observed that the creeks which drain the Homewood Addition and adjacent areas flow into this trough and are intercepted by Indian Creek. Although underlain by coarse sand and gravel, the depression is blanketed by bog deposits in many areas thus accounting for its swampy nature.

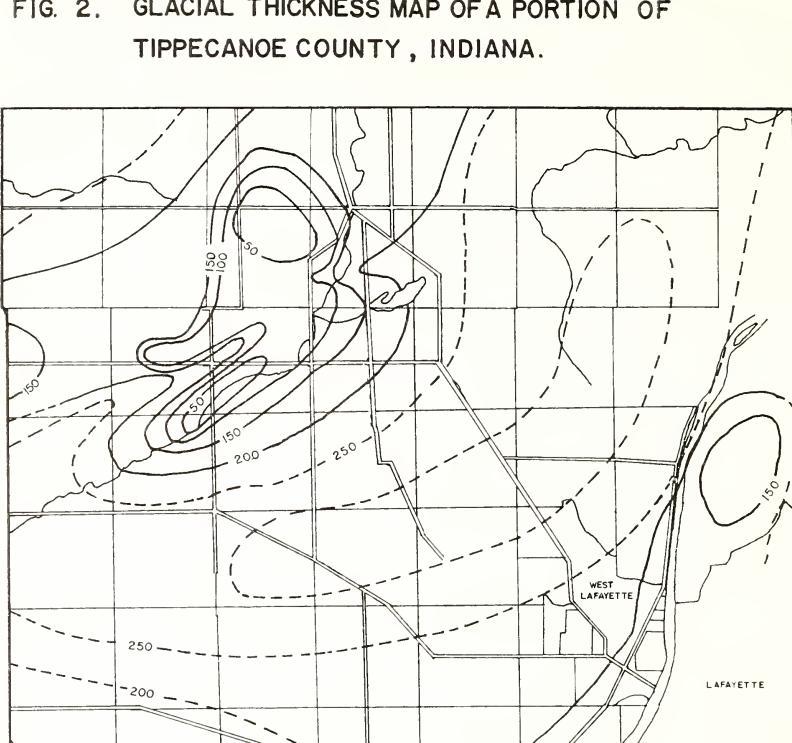
FIG. 2. GLACIAL THICKNESS MAP OF A PORTION OF

A portion of Wayne's glacial thickness map of Tippecanoe County (3) is shown as Figure 2. The existing roads transversing the area have been added to facilitate the location of local landmarks. This map, in addition to a glacial thickness map constructed by the authors from well-log and geophysical data, indicates that the maximum glacial cover in Section 35 lies in the southeast corner. This second glacial thickness map is shown as Figure 3. Toward the northwest, glacial deposits become more shallow where they overlie a high in the bedrock surface. The general stratigraphic section indicates till overlying glacial fluvial material. The deposits range in composition from clay to coarse gravel with intermediate mixtures of the two. There is considerable inter-

SCALE: I" = IMIL

ADAPTED FROM W. WAYNE . 1952.

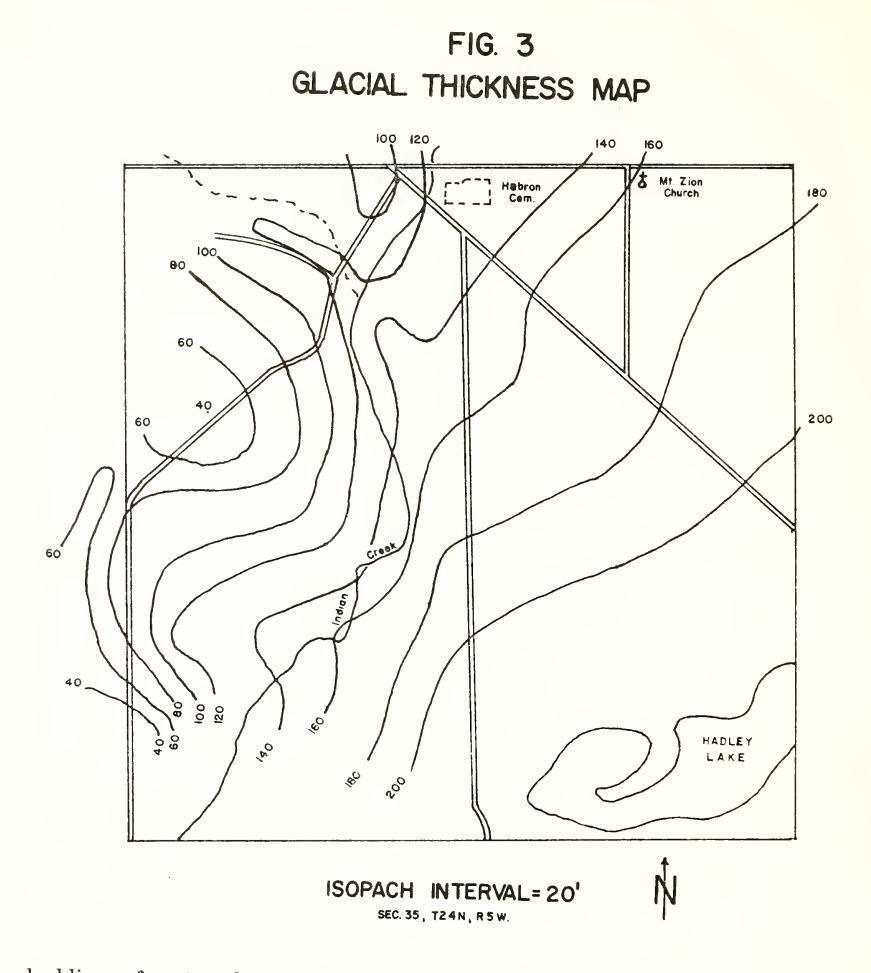
The occurrence of this tremendous water production in the midst of the considerably more modest water supplies of the area is an interesting phenomenon. Examination of the glacial thickness map presented as Figure 3 shows a V-shaped finger parallel to the creek in the Homewood area and indicates an increased glacial thickness at this point. In addition, the bedrock contour map shown as Figure 4 indicates a valley in the bedrock surface in the vicinity of well 12'.

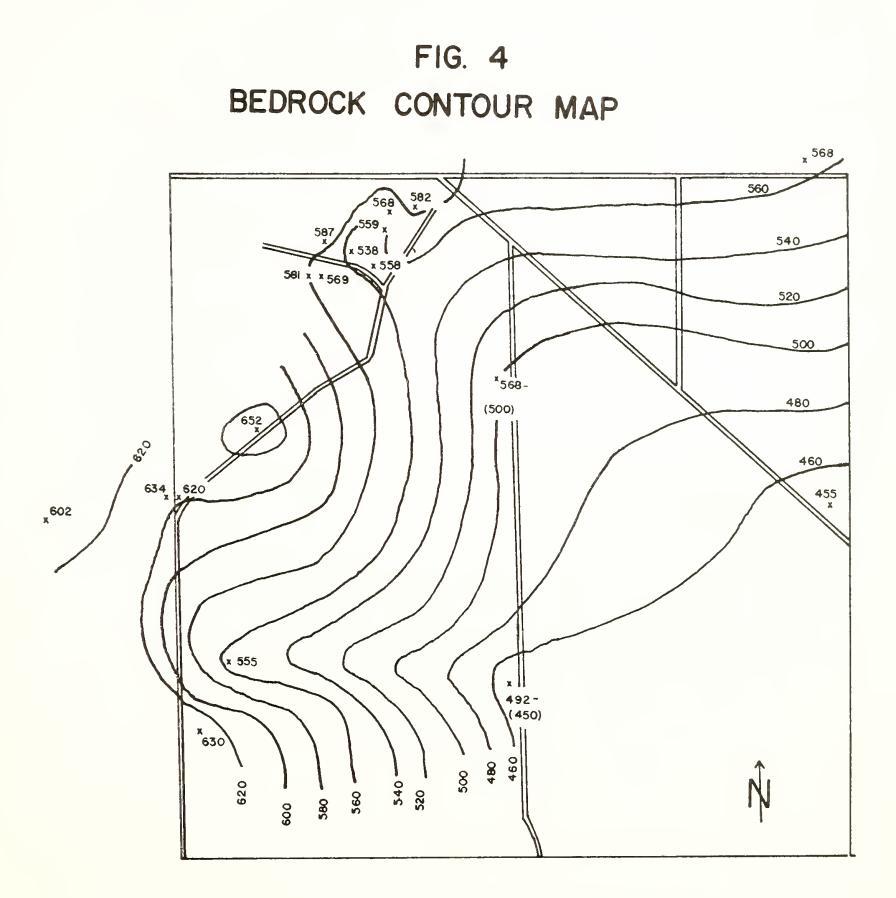
CONTOUR INTERVAL = 20' SEC 35,T 24N, R 5 W.

A bedrock map was constructed utilizing available well log data. This map is shown as Figure 4. Maximum relief on the bedrock surface is approximately 97 feet and the surface slopes from the northwest toward the southeast. The maximum elevation observed is 652 feet whereas the lowest is 455 feet.

Two valley systems are indicated on this bedrock map. One slopes eastward from an area about ½ mile south of Homewood whereas the second slopes southeast from the central portion of the Homewood area itself.

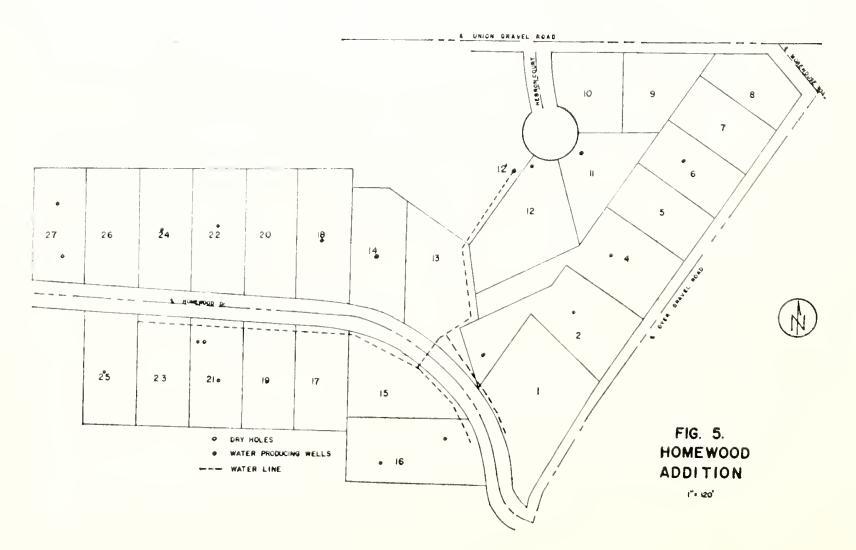
A map of the Homewood Addition is shown as Figure 5. The location of water producing wells and dry holes are indicated on this map. Homes have not been constructed to date on lots 7 through 10 so no well records are available in that region. A producing well is located on a neighboring farm just north of the intersection of Hebron Court and Union Road which indicates a suitable water supply in that general area.

Groundwater supply is notablypoorsouth of Homewood Drive. Five dry holes have been drilled to date in this region and the single producing well on lot 25 was obtained only after lengthly operations which may have included gravel packing of the well.

The area just north of Homewood Drive is somewhat better in that dry holes are not normally encountered in this vicinity. Water supply, however, is not as abundant here as in other parts of the housing area.

The largest producing wells in the subdivision lie near the circumference of Hebron Court. The well designated No. 12' was test pumped at 150+ gallons per minute and has the greatest production in the area. This well currently supplies six houses and provisions are available for a seventh house on lot 15 when it is constructed at a later date. The location of the connecting waterline is shown by a dashed line which leads from the well location at 12' to the problem area south of Homewood Drive.

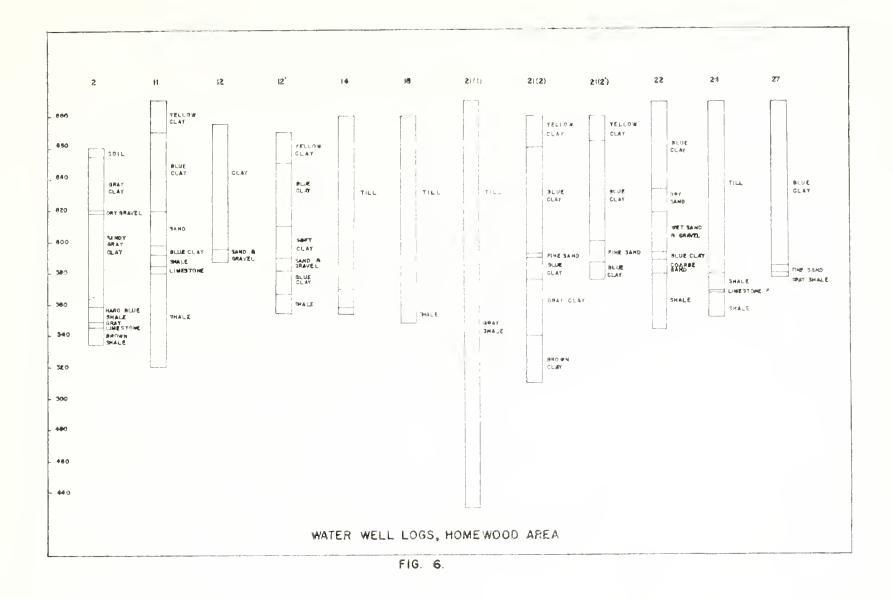
Well log data for the area are shown in Figure 6. Much of this information was obtained directly from the homeowners as well logs have not been recorded for all wells in the area. It can be observed that the depth to bedrock is of the order of 100 to 110 feet.

Several well logs on Figure 6 indicate limestone beds within the shale bedrock, usually at a depth of about 140 feet. Several of the owners of the wells in question have stated that their drillers claimed that this limestone bed was the water producing zone of the well. In other deep wells in the area, for one example 21a, this limestone was not intercepted. Owing to the fact that the Borden siltstone is calcareous in the area and its gray color may be confused with that of many limestones, the existence of this limestone layer is in some doubt and the possibility of it being an acquifer is questioned. The Borden group at this location is extremely tight and water production from lenses within it are doubtful. However, more than one well driller has reported this rock member so that its existence should not be dismissed entirely.
